Sun Blade™ 6000 Disk Module Product Notes

Part No. 820-1709-13
October 2009, Revision A

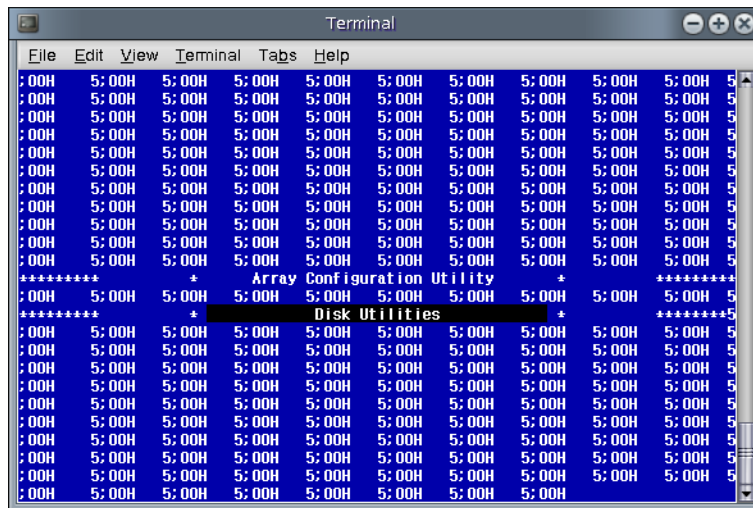
FIGURE 2-1 Scrolling Characters in Adaptec BIOS Main Menu

On the SP Console, Scrolling Characters Cause Difficulty in Cursor Navigation (6812100)

When a Sun Blade 6000 Disk Module is connected to a Sun Blade RAID 5 Expansion Module (X4620A) and you attempt to connect to the BIOS through the SP the screen will be obscured by scrolling "5:00H" characters.

1. Don't use the SP. Connect to the host blade directly.
2. Use the Sun Blade G2 RAID 0/1 Expansion Module (X4607A).

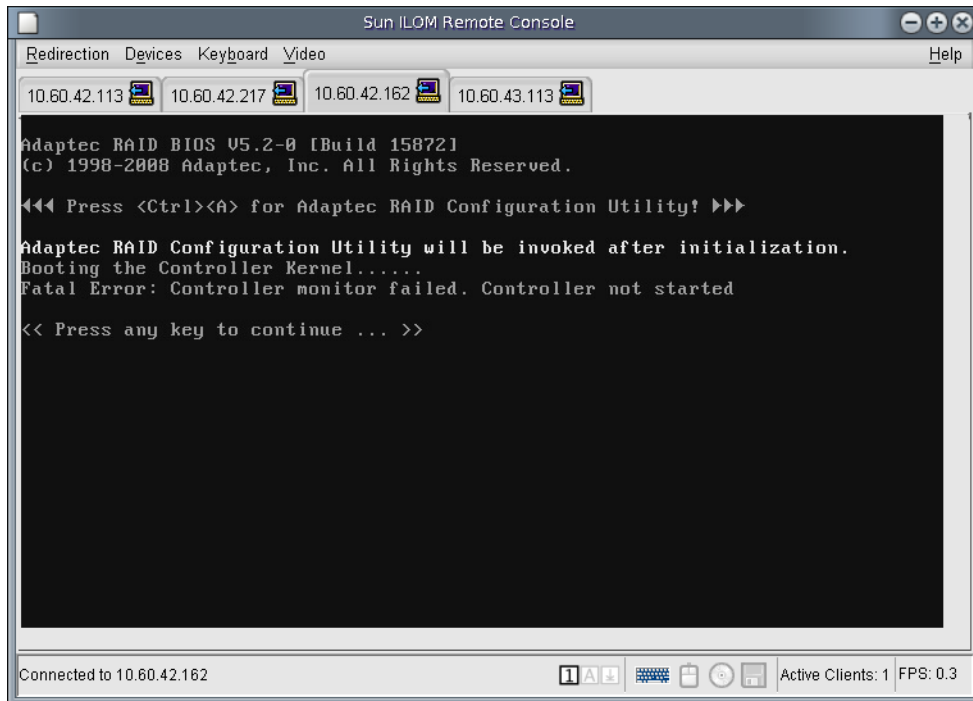
FIGURE 2-2 Reboot Hang

Controller Kernel Stops Running After Reset (6793466)

The HBA hangs during system reboot or boot up.

▼ To reset the controller:

1. Shut down the CPU blade by pressing the power button in the front panel.
2. Eject the Sun Blade 6000 away from the chassis backplane.
3. Eject all internal HDDs from the backplane (if any).
4. Power up the CPU blade.
5. Press <Ctrl-A> at the RAID BIOS to enter BIOS CU. Make sure that there is no disk in the system.
6. Press <Esc> to exit RAID BIOS and reboot the system. Repeat Step 5, and continue to step 7
7. Press the CPU blade power button to shut down the system.

▼ To reboot the system after reset:

1. At the power off, insert Vela back to the same slot configuration.
2. Insert all internal hard disk drives back to their own slots (If any)
3. Power up the CPU blade.

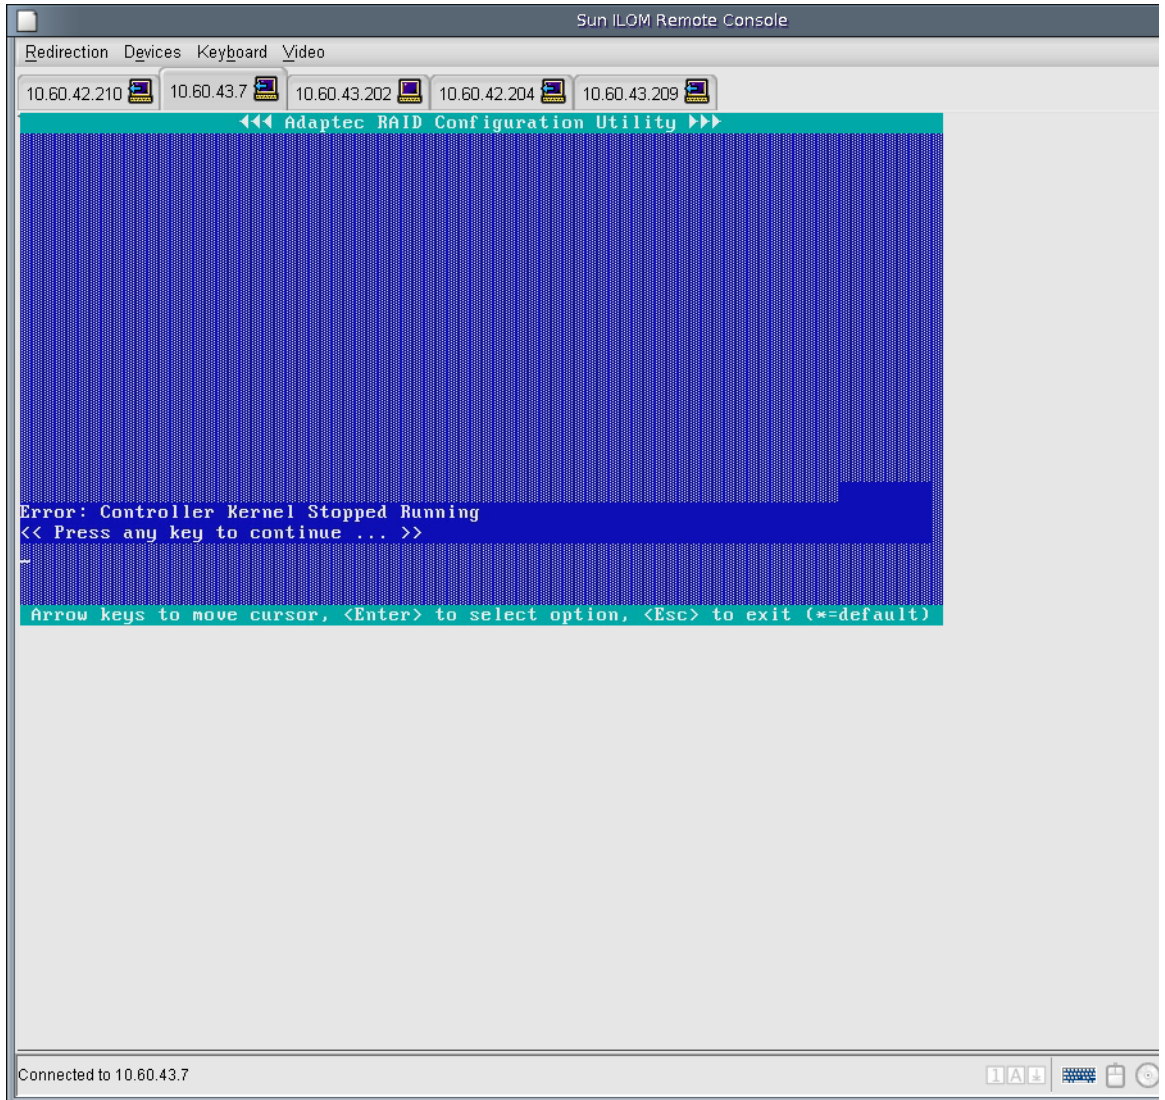
FIGURE 2-3 Controller Error

The HBA crashes in the Adaptec BIOS RAID manager.
